ADRE® for Windows - instrumental in solving a complex vibration problem on a boiler feedwater pump

*Saudi Consolidated
Electric Company,
Kingdom of Saudi Arabia*

(PIR) bearings on the Main Boiler Feedwater Pump. The vibration problem apparently developed after the pump's seal water sleeve was replaced because of excessive leakage. According to the plant's vibration group, the vibration amplitude on the pump outboard bearing vibration increased to 254 μm (10 mil) pp when the machine attained full speed.

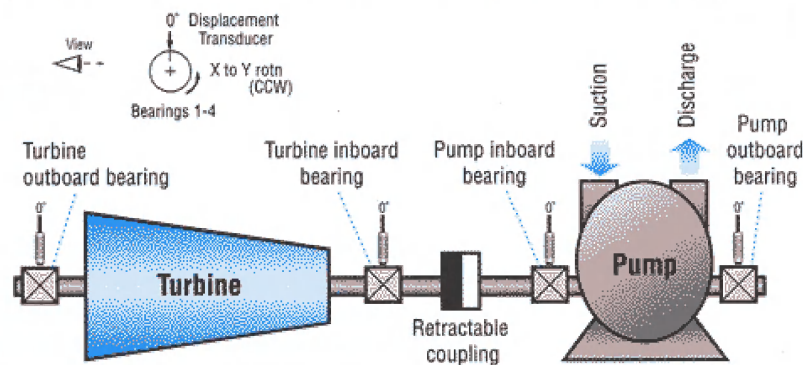
Figure 1. Unit 4 main boiler feedwater pump machine train configuration.

coupling (Figure 1). The pump suction flow (machine load) is controlled by adjusting the turbine speed. Proximity probes are mounted on the bearings in the vertical direction and connected to the Bently Nevada vibration monitors. Figure 1 shows the basic configuration of the Main Boiler Feedwater Pump.

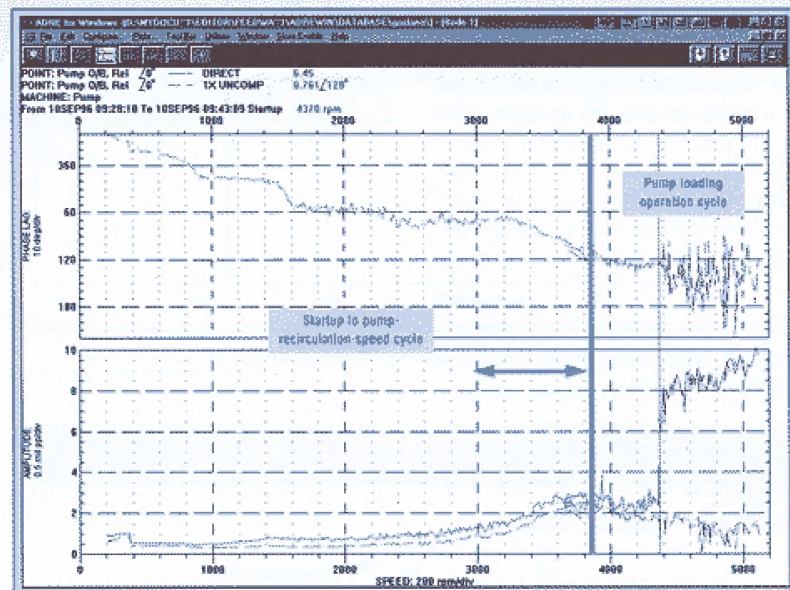
Figure 2. Bode plot of pump outboard bearing showing abrupt increase in direct amplitude at 4370 rpm.

The Bode plots (Figures 2 and 4) illustrate the abrupt increase in direct vibration amplitudes on the pump outboard and inboard bearings at 4370 rpm during pump loading. The half spectrum cascade plots (Figures 3 and 5), on the other hand, show subsynchronous peaks at 0.87X rpm, which were mainly responsible for the remarkable increase in vibration amplitudes at the pump bearings. Similar vibration signatures and patterns were also observed on the turbine bearings, but with lower amplitude levels. This vibration behavior was considered the result of the extremely high vibrations on the pump and was, therefore, not included in the analysis.

The Bode plot shown in Figure 2 indicates that the pump has a balance resonance frequency occurring at 3790 rpm. This is unusual in that most pumps, due to the hydraulic stiffening influence of the seals, typically have their balance resonance frequency above operating speed. The system stiffness of a pump is determined by the rotor geometry, seals, and bearings. If the stiffness properties of any of the elements is degraded or weakened, the resonance frequency will be lowered. It was noted by inspection that the rotating balance disk had a longitudinal

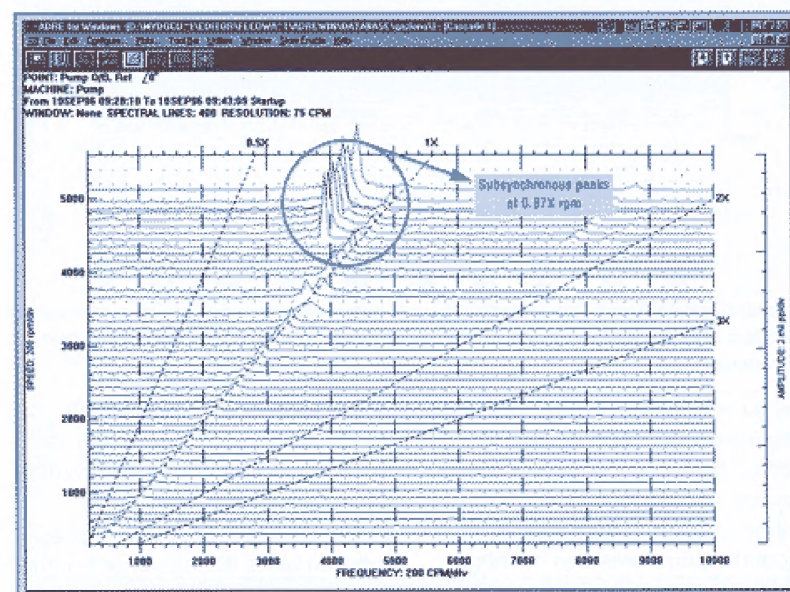
Figure 3. Half spectrum cascade plot of pump outboard bearing showing the sub-synchronous peaks at 0.87X.

The subsynchronous peaks in Figures 3 and 5 were first thought to be an oil whip phenomenon on the pump bearings. However, the machine uses tilting pad type bearings, which are normally not susceptible to oil whirl and oil whip induced vibrations. Besides, oil whip signatures normally manifest at less than 0.5X (2600 cpm in this case) and not at 0.87X (4370 cpm),

During the pump loading cycle, a subsynchronous vibration occurred at 0.87X. The pump speed at which this occurred was 4370 rpm. The source of the subsynchronous vibration is the excitation of the resonance frequency ($4370 \times 0.87 = 3801$ cpm). As the pump speed was increased from 4370 to above 5000 rpm, the subsynchronous vibration remained at 0.87X. As the pump is loaded, additional stiffening occurs from internal seals and wear rings. This increases the resonance frequency and maintains the excitation at 0.87X.

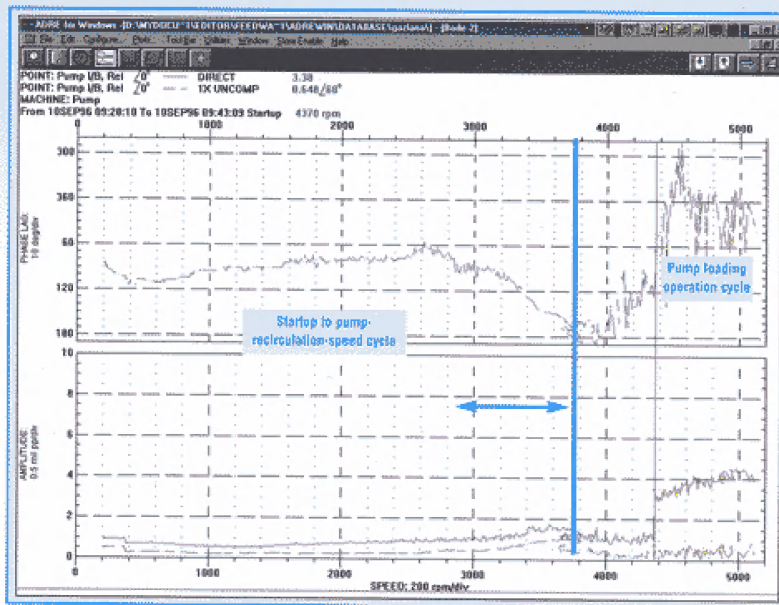
Figure 4. Bode plot of pump inboard bearing showing abrupt increase in direct amplitude at 4370 rpm.

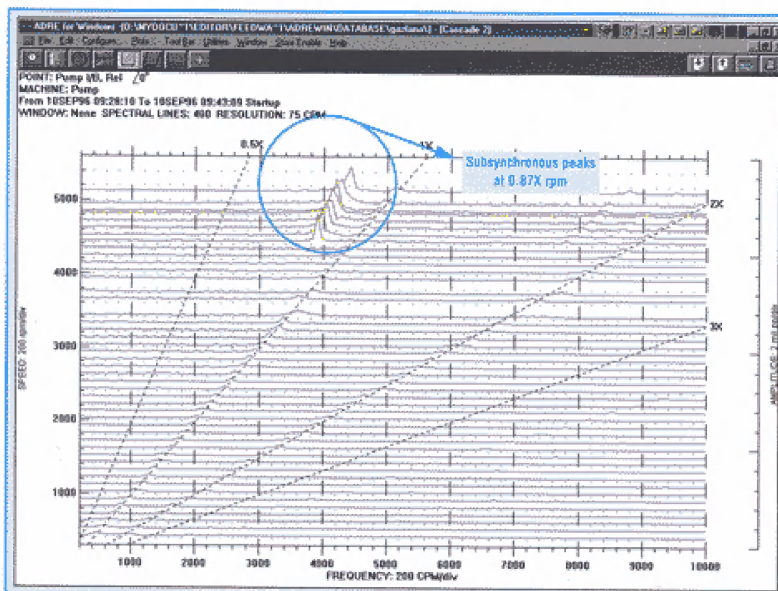
Figure 5. Half spectrum cascade plot of pump inboard bearing showing the subsynchronous peaks at 0.87X.

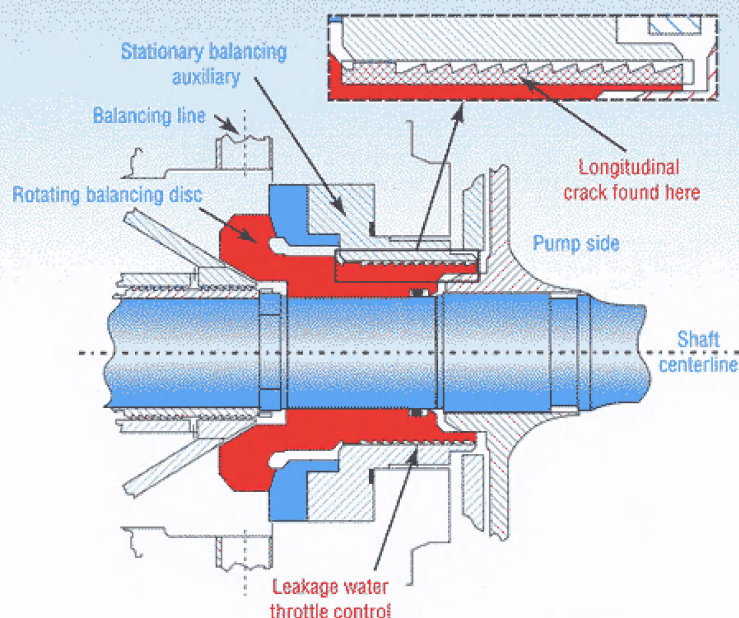
Figure 6. Cutaway view of balancing drum assembly.

The information gathered from the plant provided a clear understanding on the pump operation and internal components and gave an insight into the source of the problem. It was understood that the pump rotor stability and fluid flow balance during operation were primarily maintained by the balancing drum assembly. A cutaway view of a balancing drum assembly (Figure 6) shows the different components responsible for the control process.

An inspection of the pump internals revealed a longitudinal crack in the rotating balancing disc in the balancing drum assembly. The entire pump rotor assembly was replaced instead of just the balancing drum because of concern about the integrity of the other internal parts on the existing rotor.

The crack in the balancing disc resulted in the loss of throttle con-

trol of pump water leakage to the balancing chamber. The excessive pump water in the balancing chamber contaminated the seal water. The contamination rendered the seal water control inoperable because the seal water temperature reached the saturation point of the

controller, 93 °C (200 °F). The seal water control was essential in maintaining the pump rotor stability and fluid flow balance during operation.

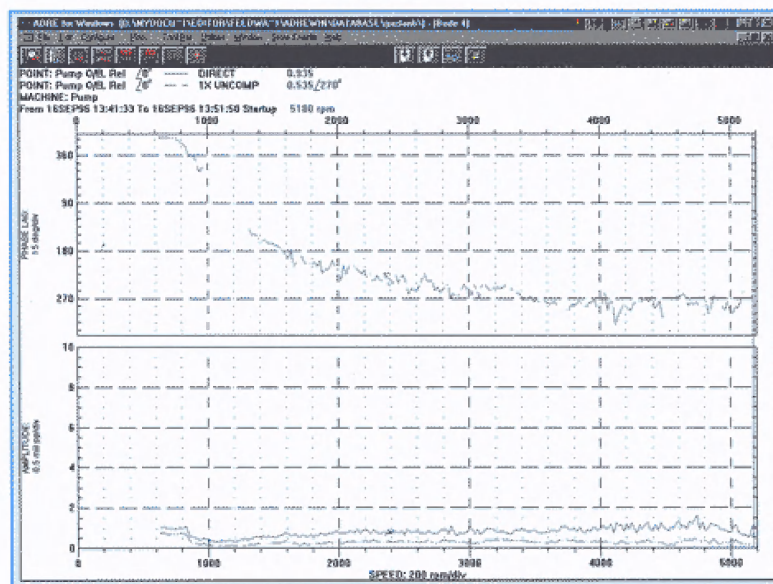
The machine behavior and vibration signatures observed in the survey conducted after replacement of the pump rotor assembly were normal. The Bode plots on the pump bearings (Figures 7 and 8) obtained during the survey on September 16, 1996, showed the normal pattern and low vibration amplitudes during the startup to load condition. Pump abnormalities seen during loading operations and before the correction were no longer present.

Figure 7. Bode plot of pump outboard bearing after replacement of pump rotor assembly.

Upon completing repairs to the pump, the pump was restarted on September 16, 1996. The Bode plot shown in Figure 7 indicates satisfactory operational vibration levels. It further indicates the absence of a balance resonance at 3790 rpm. ☺

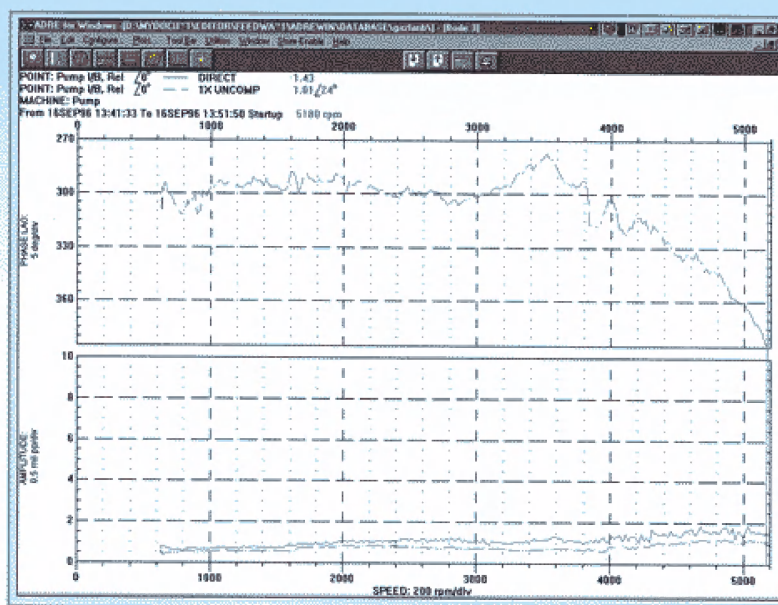
Figure 8. Bode plot of pump inboard bearing after replacement of pump rotor assembly.
